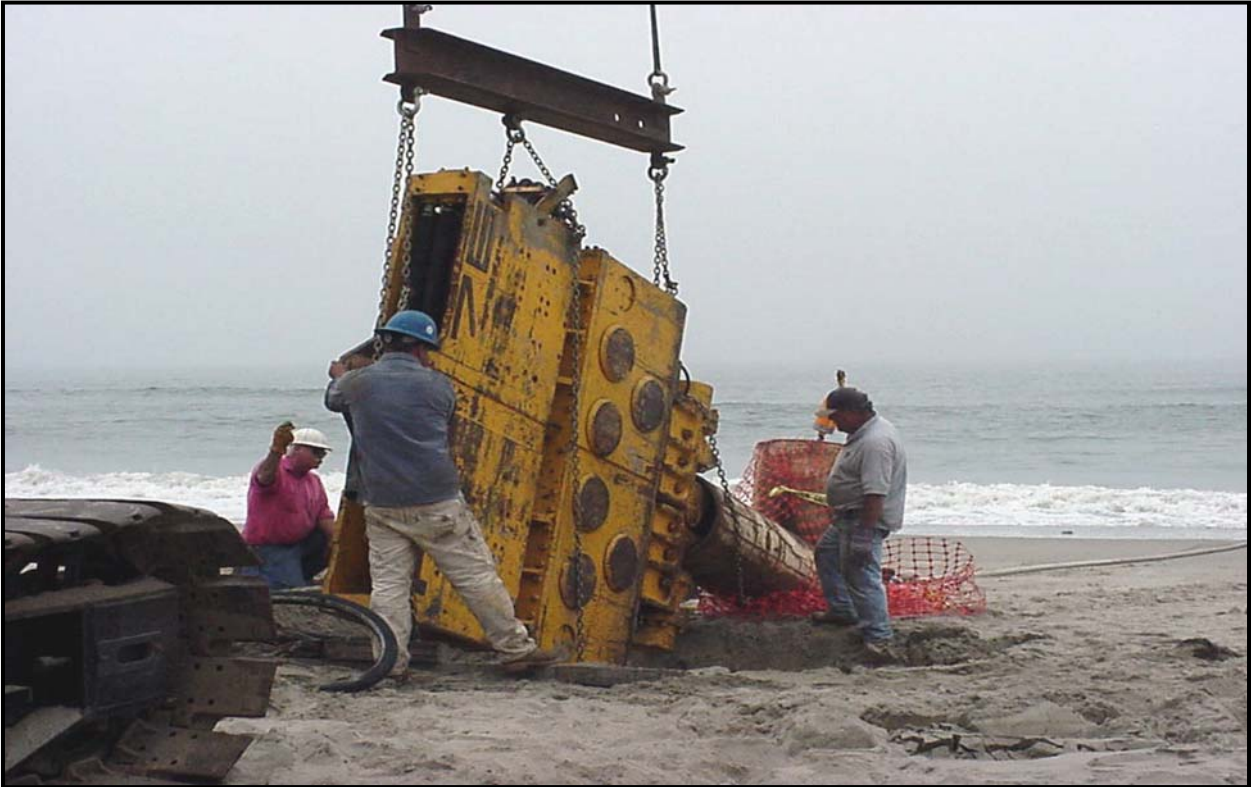
A-5. Vibratory extraction of nearshore pipeline segment.

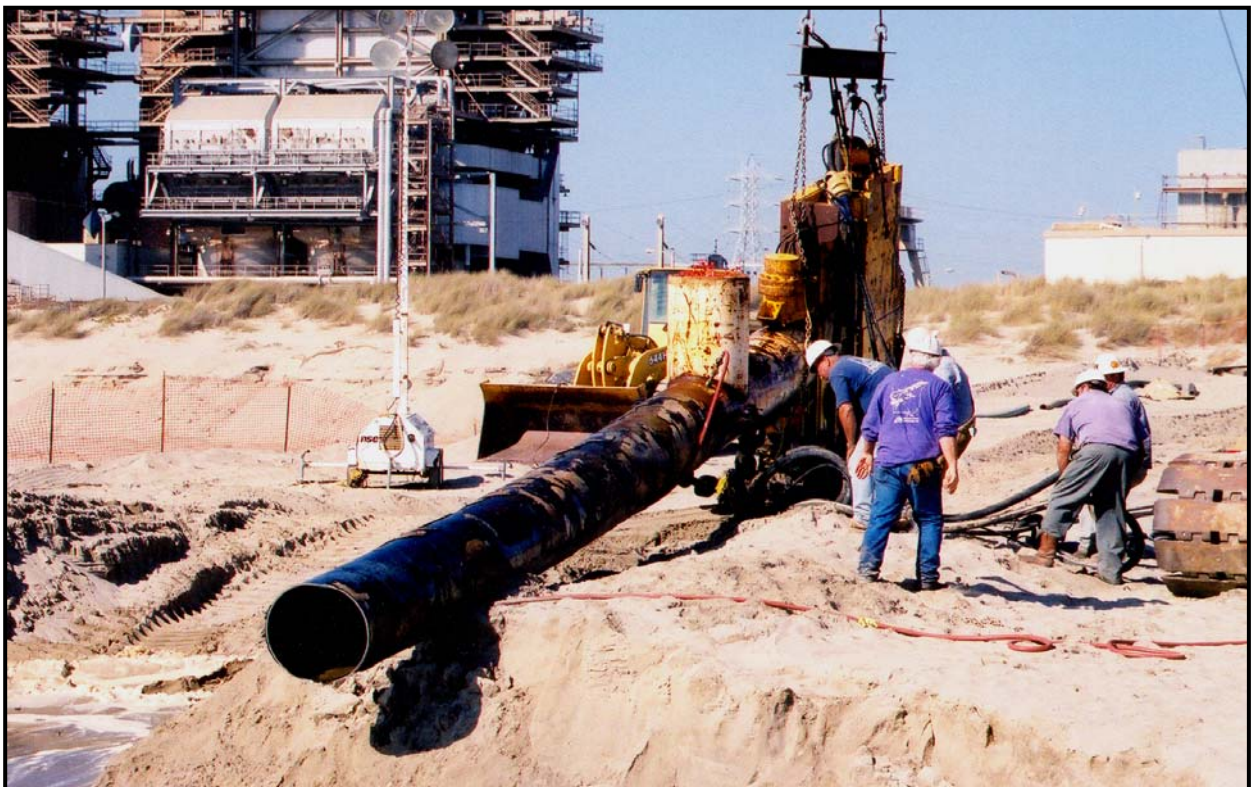
A-6. Broken pipe after one of three unsuccessful attempts at vibratory extraction.
